# INDOOR AIR QUALITY ASSESSMENT

**Mass Bay Transit Authority  
Engineering Building, Building 2  
21 Arlington Avenue  
Charlestown, MA**

Prepared by:  
Massachusetts Department of Public Health  
Bureau of Environmental Health  
Indoor Air Quality Program  
October 2019

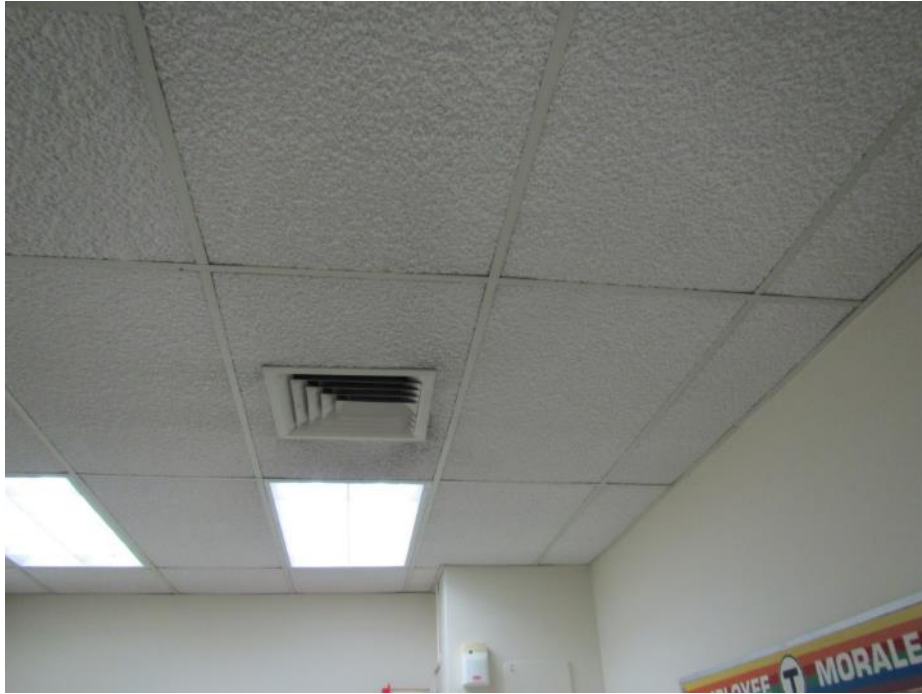
**Picture 1**

No direct examination of the HVAC system was able to be made during this visit. Based on observations made, the second floor appears to have fresh air supplied by ceiling-mounted vents (Picture 1) and ceiling-mounted return vents (Picture 2). No vents were noted on the first floor, which likely accounts for the higher carbon dioxide levels measured. This HVAC configuration may be a holdover from previous use as a warehouse. Ducts for fresh air existed at the top of a high open area in its original configuration. The warehouse was subsequently divided into two complete floors with no HVAC system installed on the first floor.

**Ceiling-mounted supply vent**

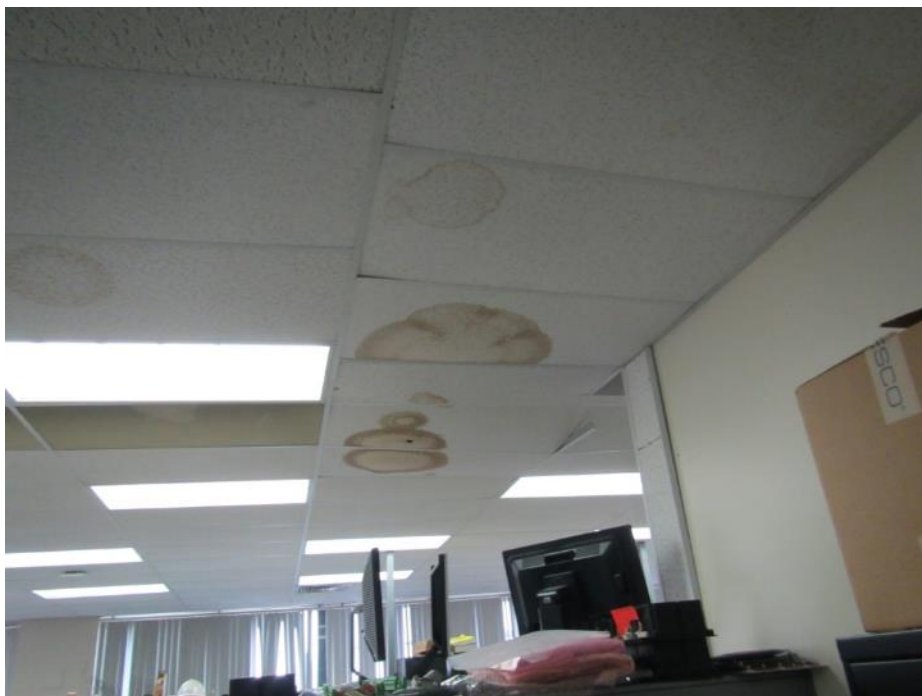
**Picture 2**

Occupant concerns that prompted this assessment specifically mentioned mold and moisture. Water-damaged ceiling tiles were observed in many areas on the top floor, likely from roof leaks (Pictures 2, 5 and 6). In some areas, tiles had been removed due to repeated moistening. Ceiling tiles are porous materials that may grow mold if moistened for a sufficiently long period of time. None of the tiles appeared to be mold-colonized, however conditions leading to chronic water damage to building materials should be corrected to prevent microbial growth in the future. Water-damaged ceiling tiles should be removed and replaced when discovered. The ceiling plenum above the suspended ceiling should be examined for signs of water damage/microbial growth and cleaned as needed.

**Ceiling-mounted return vent, also note water-damaged ceiling tiles**

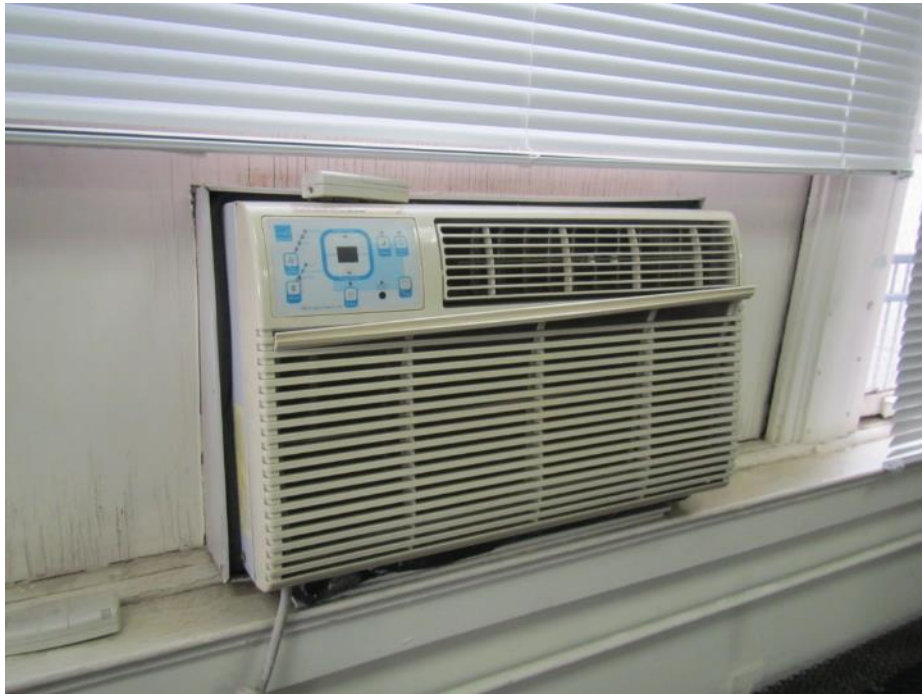
**Picture 3**

Other water-damaged materials were noted, including water staining under sinks, and deterioration/cracking of wooden panels around WACs (Picture 3). Wall plaster in one office on the first floor was cracked and spalling (Pictures 7 and 8). While plaster, metal, and floor tile are non-porous and resistant to mold growth, the damaged wall creates dust and debris, and chronic water penetration will moisten other nearby areas/items in the room, which are conditions that will worsen as the wall integrity is further compromised. The building envelope exterior in this area should be repaired to prevent water penetration. Until repairs can be done, items/furniture should be moved away from the wall to prevent water damage, and debris should be cleaned regularly.

**Window-mounted air conditioner, note cracked and water-damaged wooden framing**

10. Until building envelope leaks can be addressed, avoid storing any porous materials in areas with known leaks.
11. Replace water-damaged wooden frames around WAC with non-porous materials.

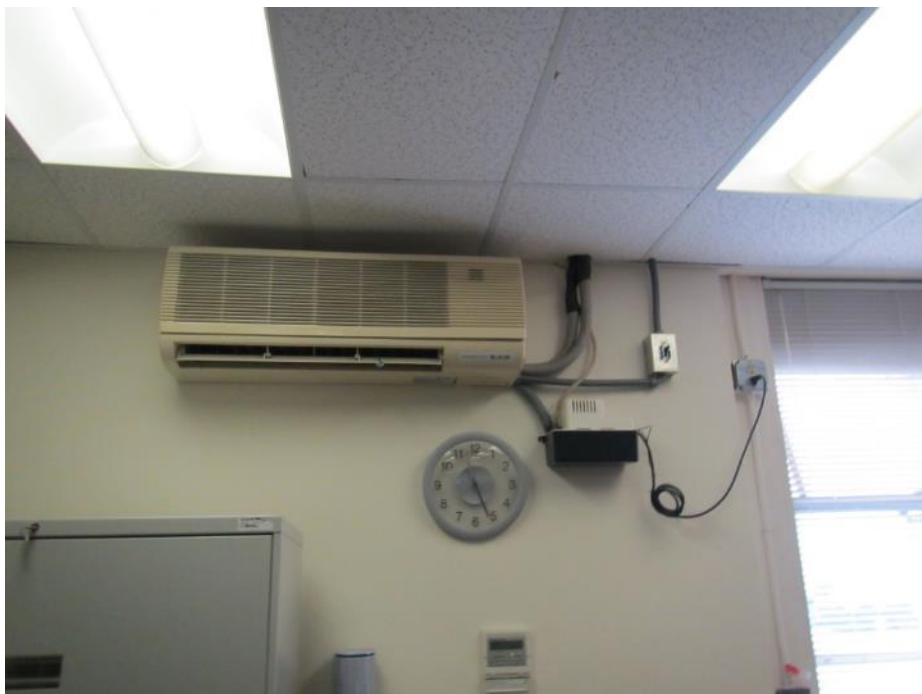
**Picture 4**

Supplemental heat is provided by steam radiators in areas near the exterior walls. Many areas on both floors had window-mounted air conditioners (WACs, Picture 3) or wall-mounted ductless air conditioners (Picture 4) to provide cooling. Windows in some areas were open to provide fresh air. Also note that WACs can be used in the fan-only mode to introduce fresh air even when cooling is not needed.

**Ductless air conditioner with condensate pump**

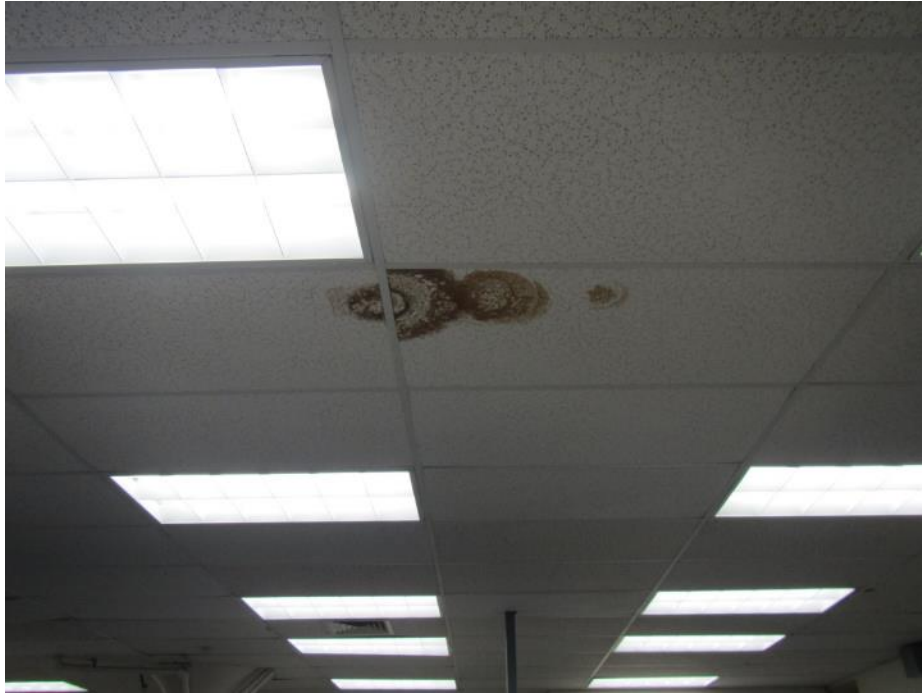
**Picture 5**

**Water-damaged ceiling tiles**

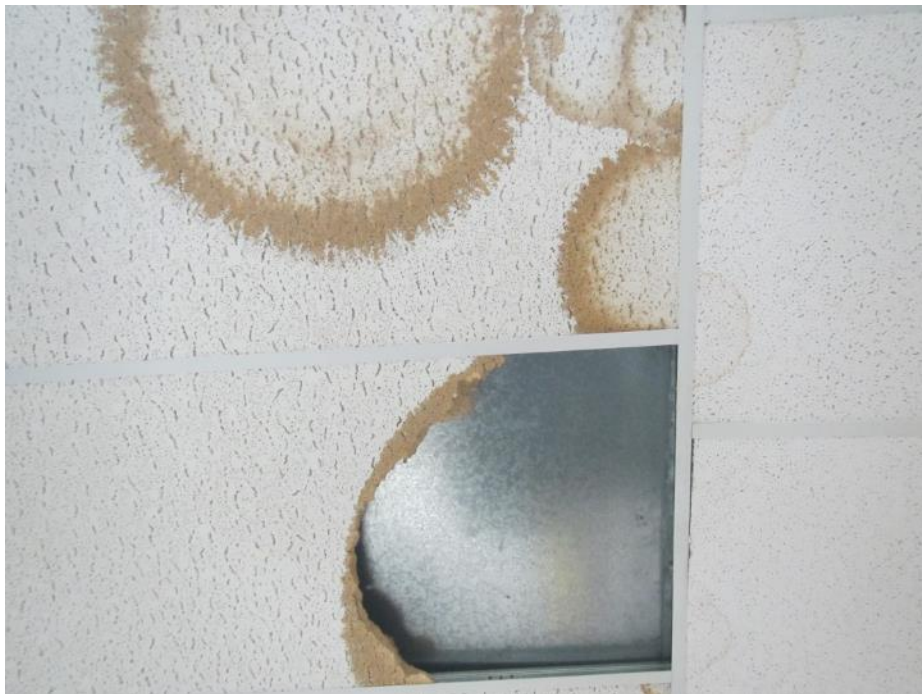
**Picture 6**

**Water-damaged and broken ceiling tiles**

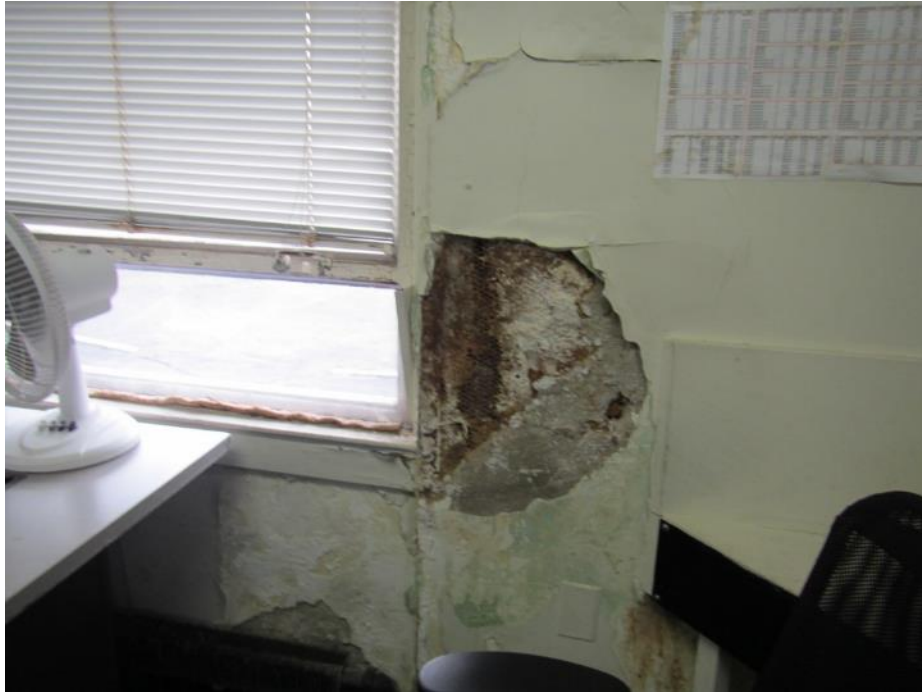
**Picture 7**

**Cracked, spalling wall in first floor office**

12. Clean debris from spalling wall shown in Pictures 7 and 8.
13. Repair or clean other water-damaged materials including areas under sinks and stained walls.

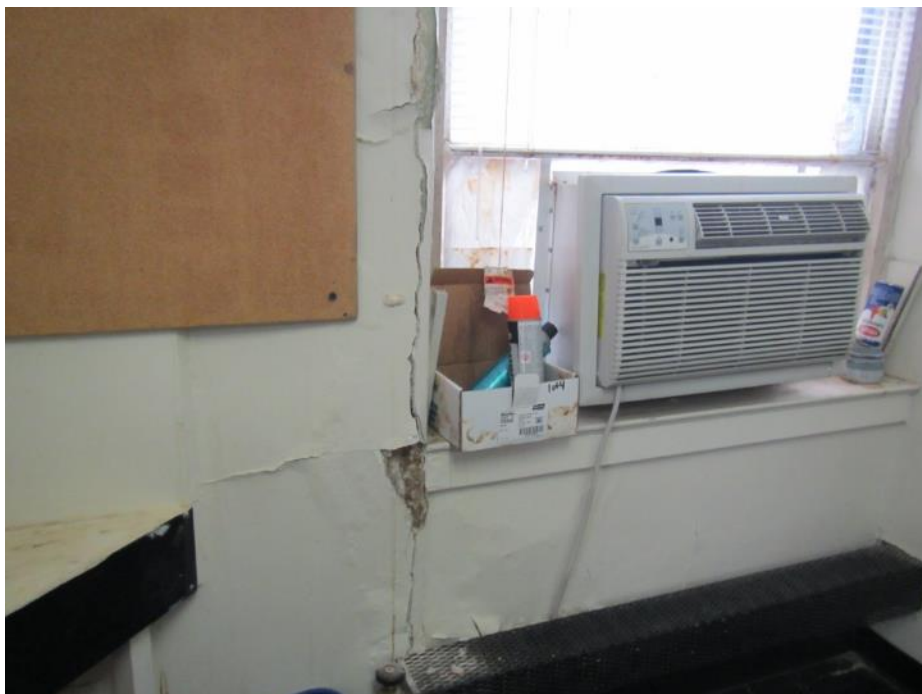
**Picture 8**

**Cracked, spalling wall and plaster debris**

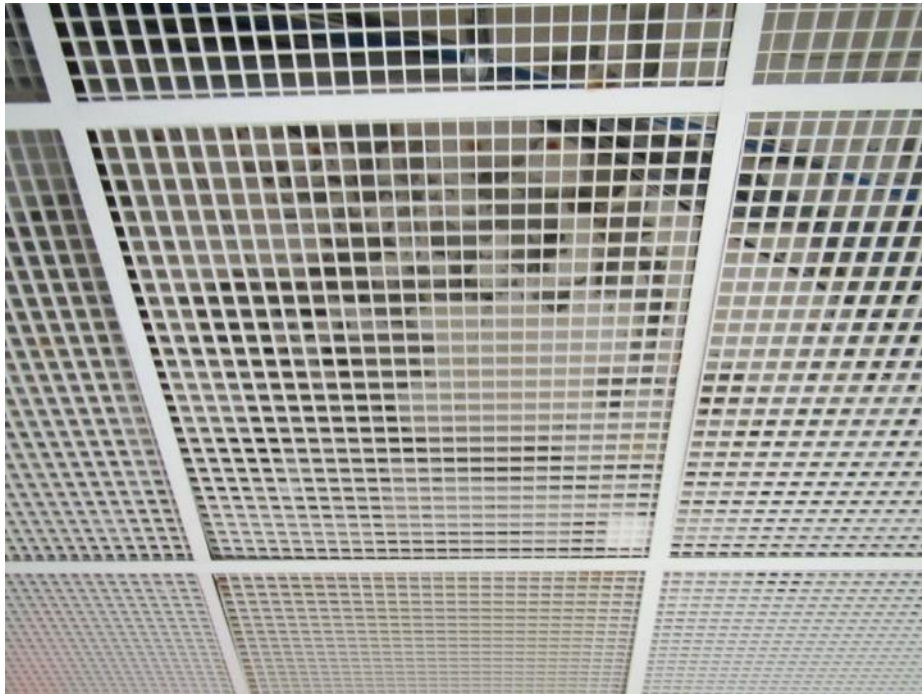
**Picture 9**

The hallway on the first floor is of particular note. The ceiling tiles in this area were replaced with open “egg crate” style vents (Pictures 9 and 10), reportedly due to excess humidity from failing steam pipes in the basement below. While these open grids no longer accumulate moisture and are unlikely to grow mold, the ceiling is now exposed to any ongoing moistening from steam. Paint on the ceiling is flaking (Picture 10) and the ceiling grid does not block paint debris from falling into occupied areas. It is possible this paint may contain lead or other regulated materials. There were also stains on walls in the hallway, likely from chronic condensation, (Picture 11) which should be cleaned.

**Egg-crate-style pieces in the ceiling tile grid in the first floor hallway**

19. Remove plants from adjacent to the building. Seal any holes and unneeded former window wells.
20. If steam leaks have been resolved, replace the “egg crate” grids with closed ceiling tiles to prevent distribution of dust/debris from flaking paint.

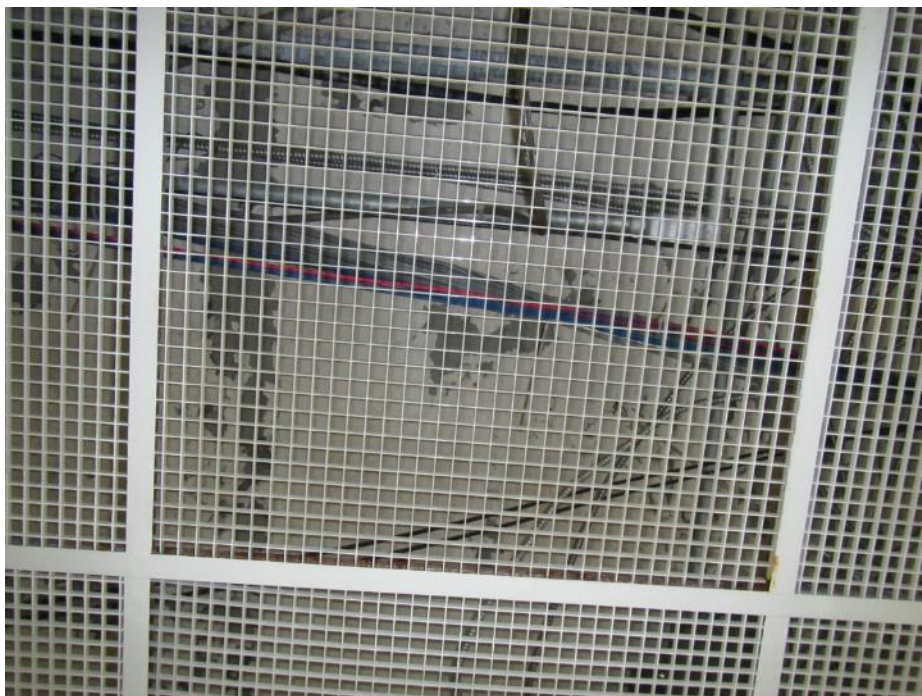
**Picture 10**

**Flaking paint on ceiling above grid**

21. Remove/repair flaking paint in hallway ceiling.
22. Reduce the use of products containing VOCs, especially scented products and air fresheners.
23. Keep items in offices organized to allow for effective cleaning. Remove items from floors and other surfaces periodically so that surface cleaning and dusting can be performed.

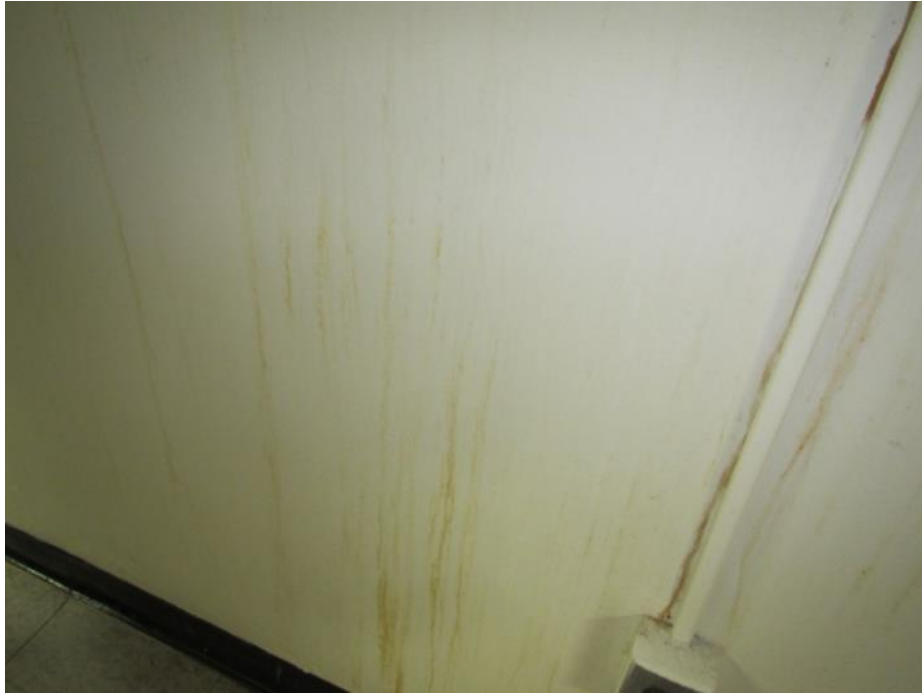
**Picture 11**

**Stains on walls in first floor hallway**

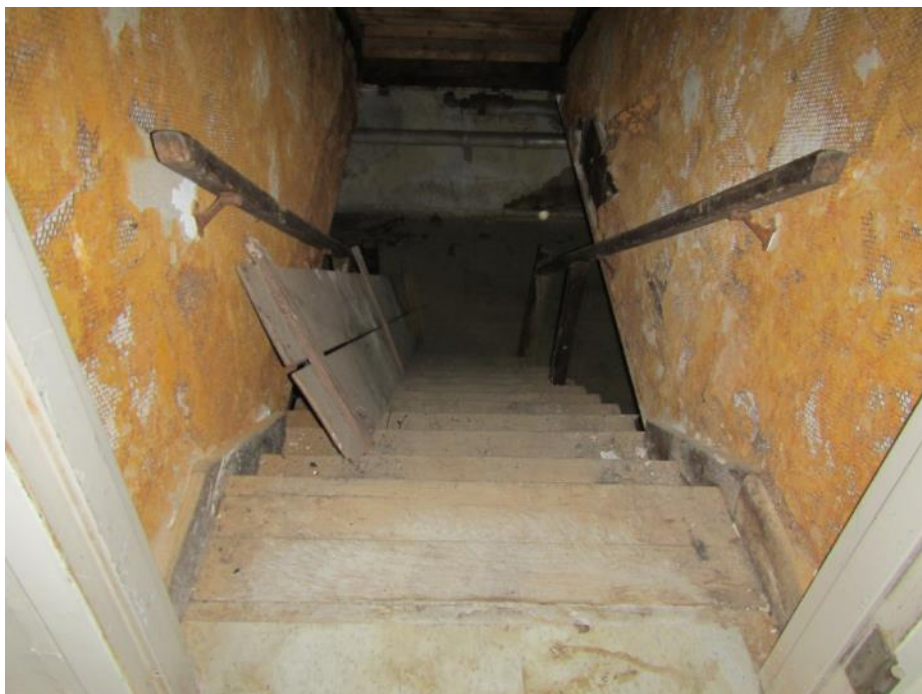
**Picture 12**

Buildings 2 and 3 have a shared basement. The entry to the basement stairs no longer has a door (Picture 12) which means any odors or dust from below can migrate to occupied areas. The ceiling in the basement had gaps and showed signs of deterioration (Picture 13) which may

Building staff reported that the basement was recently cleaned due to impacts from failing steam pipes. However, floors and other surfaces in the basement, including the stairs, had a significant coating of debris from wear to building materials (Picture 12). In addition, the relative humidity in the basement was higher than that elsewhere in the building as well as outside (69%). At 70% relative humidity, moisture from the air alone can moisten building materials and lead to microbial growth (ASHRAE, 1985). A dehumidifier should be used to keep conditions in the basement from deteriorating. In addition, nothing porous or hard to clean should be stored here.

**Basement stairway with no door on the ground floor, note debris**

14. Add/replace a doorway to the basement from the first floor. Seal other gaps/pathways between occupied and unoccupied areas.
15. Thoroughly clean debris from the basement using a HEPA-filtered heavy-duty vacuum cleaner or other method that will not disperse debris. Avoid storing any items, particularly porous or hard to clean items, in this area.

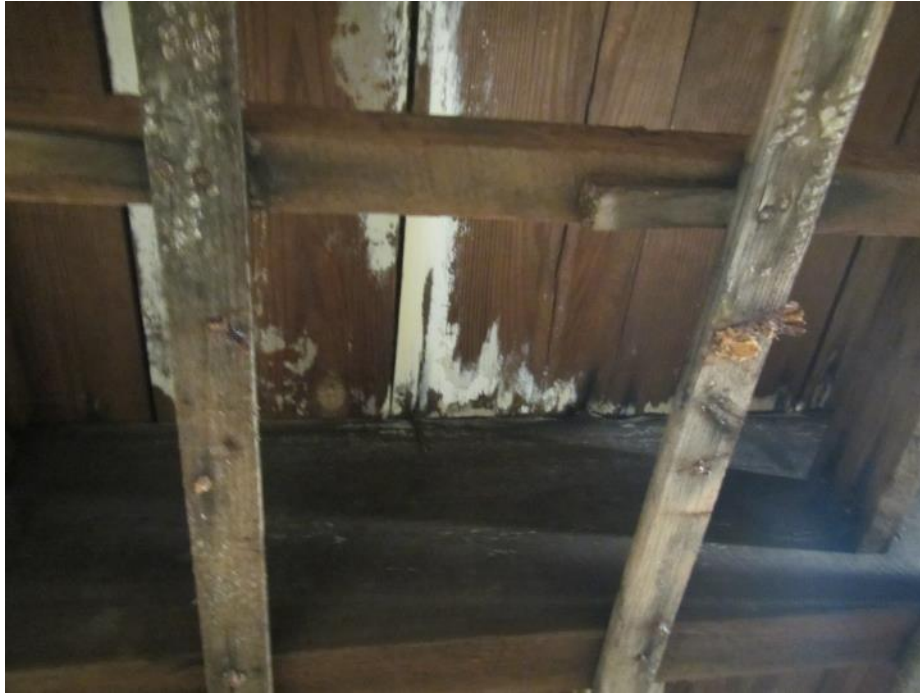
**Picture 13**

include mold growth. This also may allow moisture and odors into occupied areas of the building, particularly since floor tiles in some areas were missing.

**Poor condition of ceiling in basement showing gaps and potential mold growth**

16. Remove/repair as much damaged material in the basement as possible to reduce creation of debris.
17. Consider use of a dehumidifier in the basement. If used, ensure the equipment is emptied and cleaned periodically.

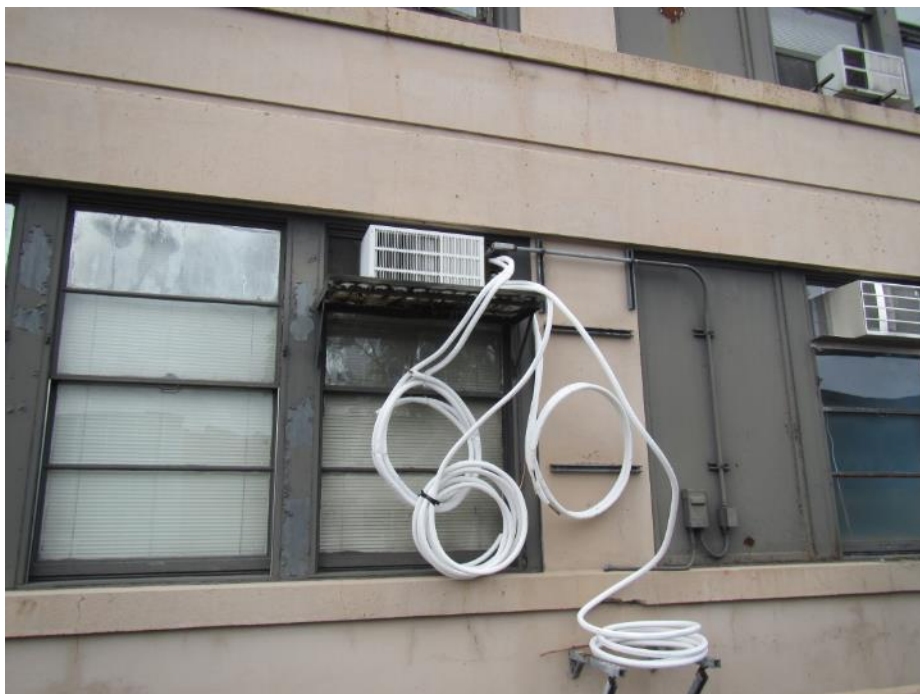
**Picture 14**

- Drain hoses for ductless air conditioning units and possibly other equipment directed outside in a disorganized manner. Hoses should be only as long as needed and should be checked periodically and cleaned as needed to prevent clogs and leaks (Picture 14);
- Plants growing close to the building and out of wells that may have once contained windows (Picture 15); and
- Damage to exterior building envelope (Picture 16).

**Disorganized condensate drainage**

18. Determine the function of various drain tubing (e.g. condensate from ductless air conditioners) and ensure all the pumps and tubing are functioning correctly to prevent leaks.

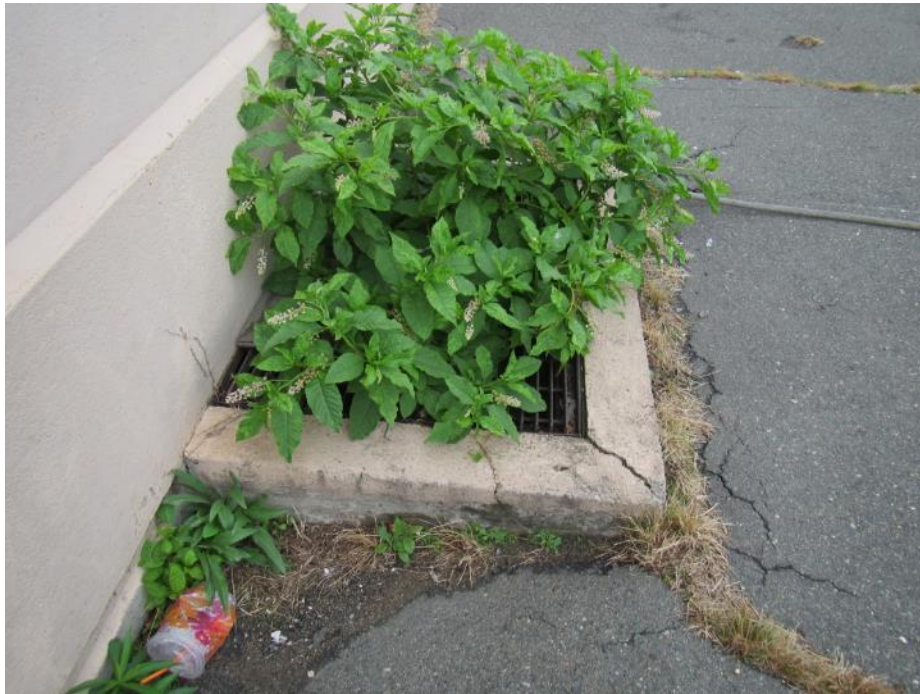
**Picture 15**

**Plant growing out of building area, possible former window well**

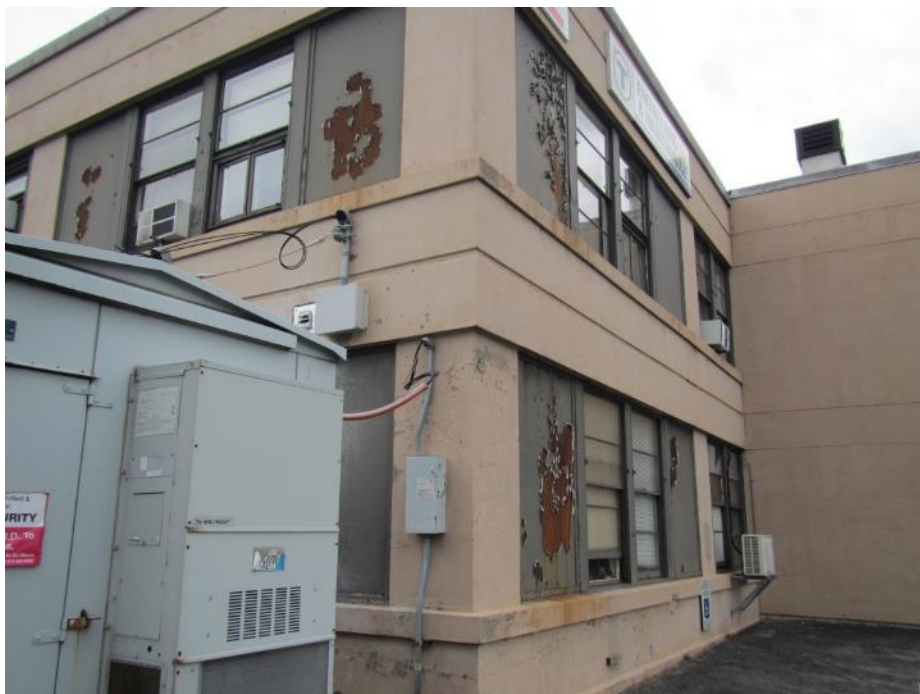
**Picture 16**

**Damage to building exterior**

1. Repair water-damaged plaster in lower level.
2. Remove remaining carpeting from offices.
3. Consult with a building engineer/construction manager to make repairs to the building envelope including the roof.
4. Finalize repairs to the steam system in the basement and consult with a basement waterproofing contractor to ensure dry conditions in the basement.
5. Consider adding a fresh-air ventilation system to the lower level.
